SISKIYOU SUMMIT NEGATIVE GRADE ARRESTER BED
FOR RUNAWAY TRUCKS

Experimental Feature Project OR 77-02
Final Report

OREGON STATE HIGHWAY DIVISION
Research Section
Salem, Oregon 97310

January 1986

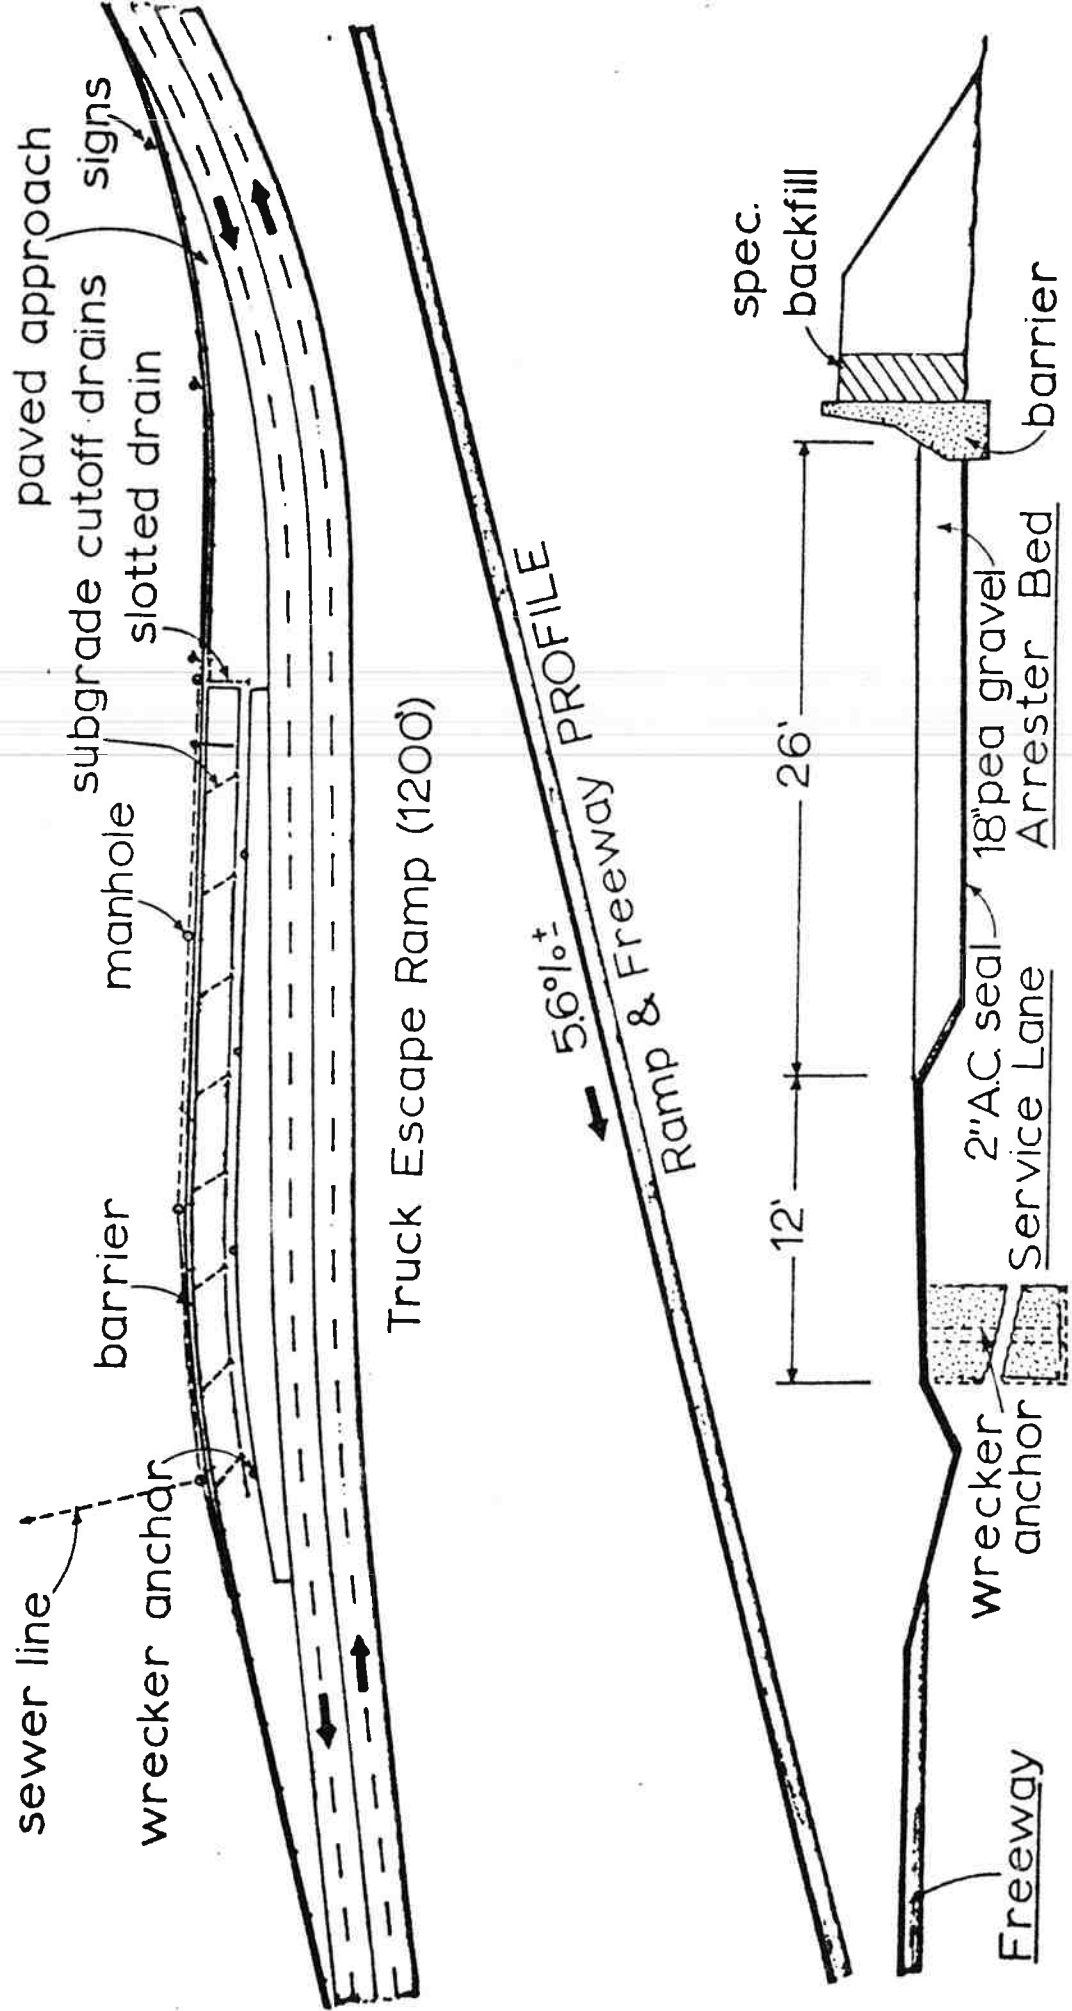
The testing was conducted December 5 through December 9, 1977, at the nearly completed 1200' long, 26' wide escape ramp (see Figure 2). The weather conditions were cool and cloudy; temperatures were mostly in the 30's and low 40's with occasional light rain. There was a thin crust of frost on the arrester bed the morning of December 8, 1977.

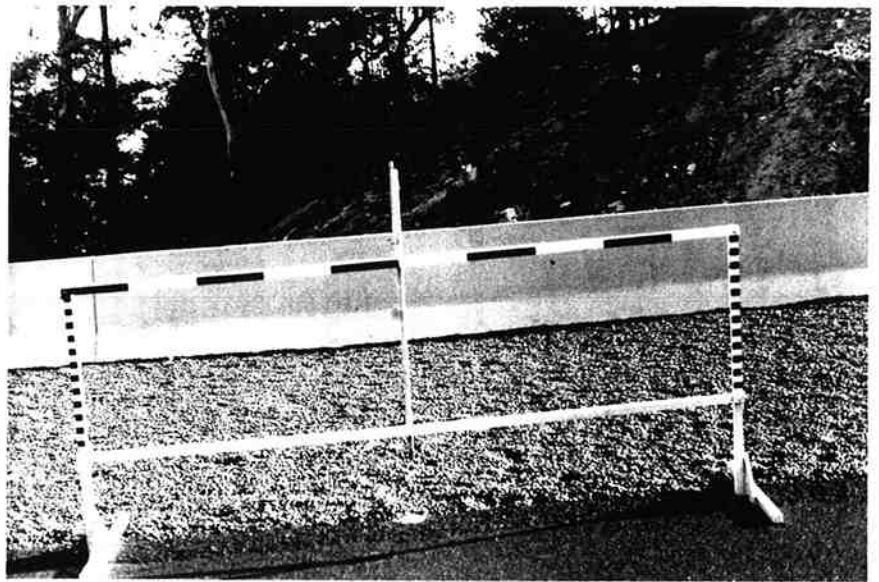
Wooden target with alternating white-black one foot long sections and vertical target bar.

Pictures were taken of the trial runs by four 16mm motion picture cameras located along the fog line of the main highway at varying distances from the start of the bed. Wooden targets with alternating white-black, one-foot-long sections and vertical target bars were placed between each camera location and the bed. A matching rod was attached to the side of each vehicle. By measuring the distance the test vehicle traveled past the vertical target bars during a set number of movie frames, the local velocity was calculated at each camera location. (See Figure 3, a set of photographs showing the testing procedure.) Comments concerning each trial were recorded where appropriate. (Appendix, Table A summarizes the results from the thirty-eight experimental tests.)

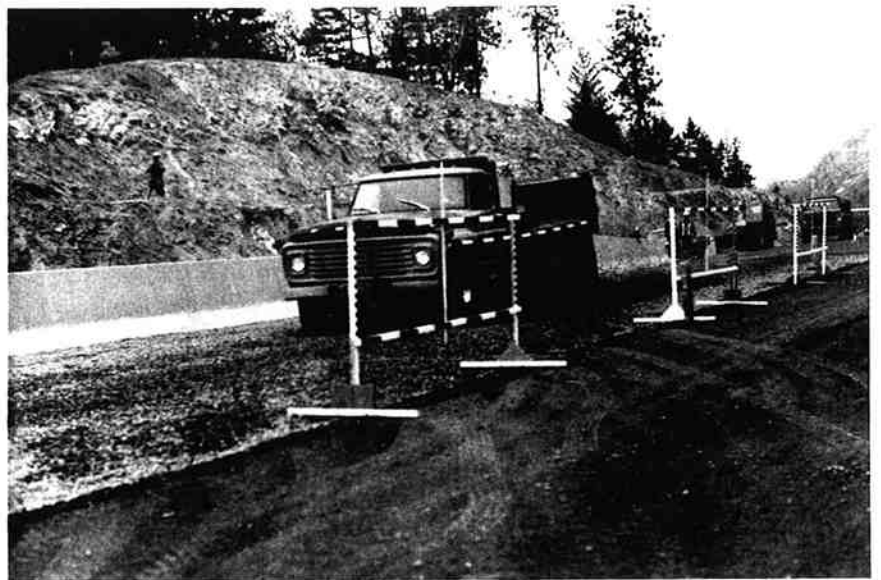
Empty five yard dump truck entering ramp.

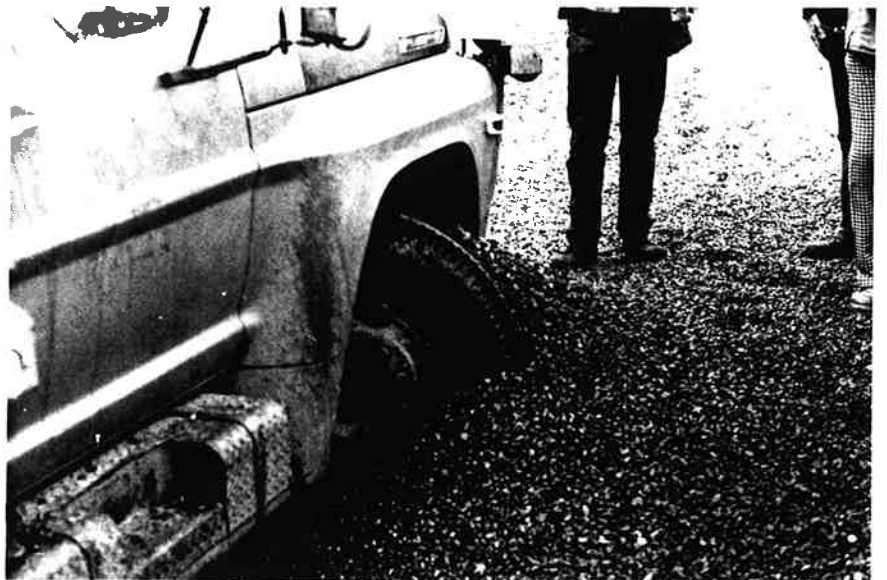
The pea gravel bed can damage vehicles.

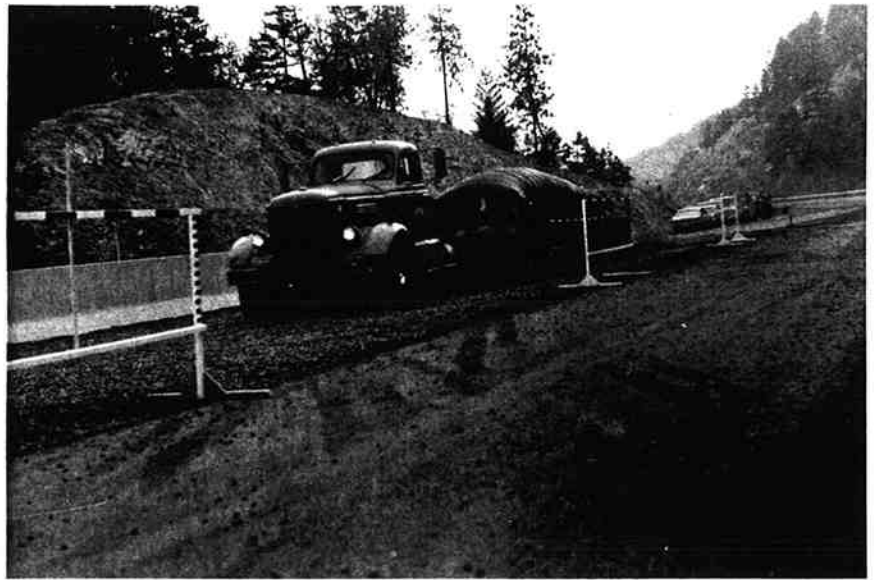
International flatbed with
water-filled rubber bladder
entering gravel bed at
40 mph...

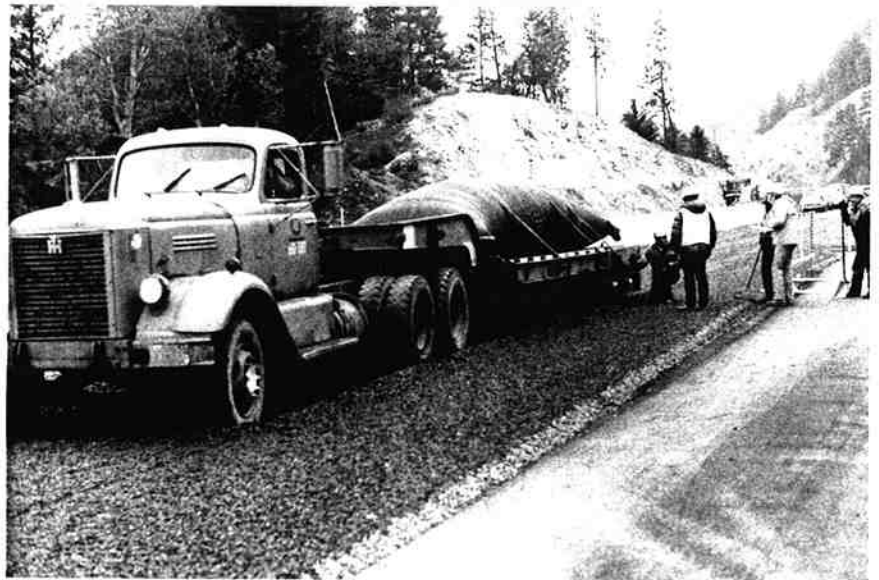
...and "arrested"
approximately 215 feet
into the bed.

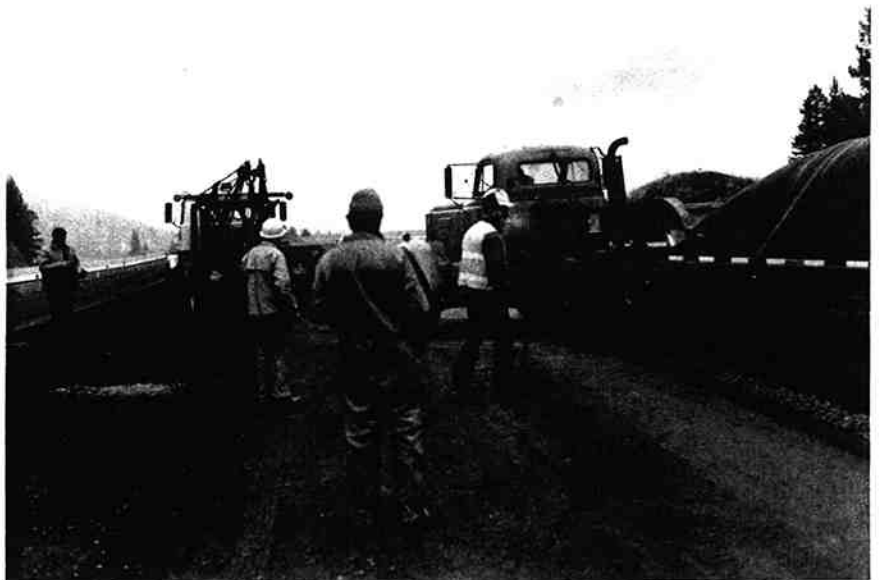
Vehicles must be towed out
of the bed.

- 3) Terraced beds or beds with transverse mounds are not recommended because of possible vehicle damage and possible loss of control of the vehicle.
- 4) A paved service ramp alongside the arrester bed is necessary to allow tow trucks access to pull trucks from the bed. Tie downs to anchor the tow trucks should be provided at least every 300 feet along the service road. These anchors should be placed off the edge of the service ramp away from the arrester bed in order to provide the proper angle to pull trucks out of the bed and onto the service road. One anchor needs to be placed at the 150 to 200 foot distance to assist in removing trucks which have entered only a short distance into the bed.

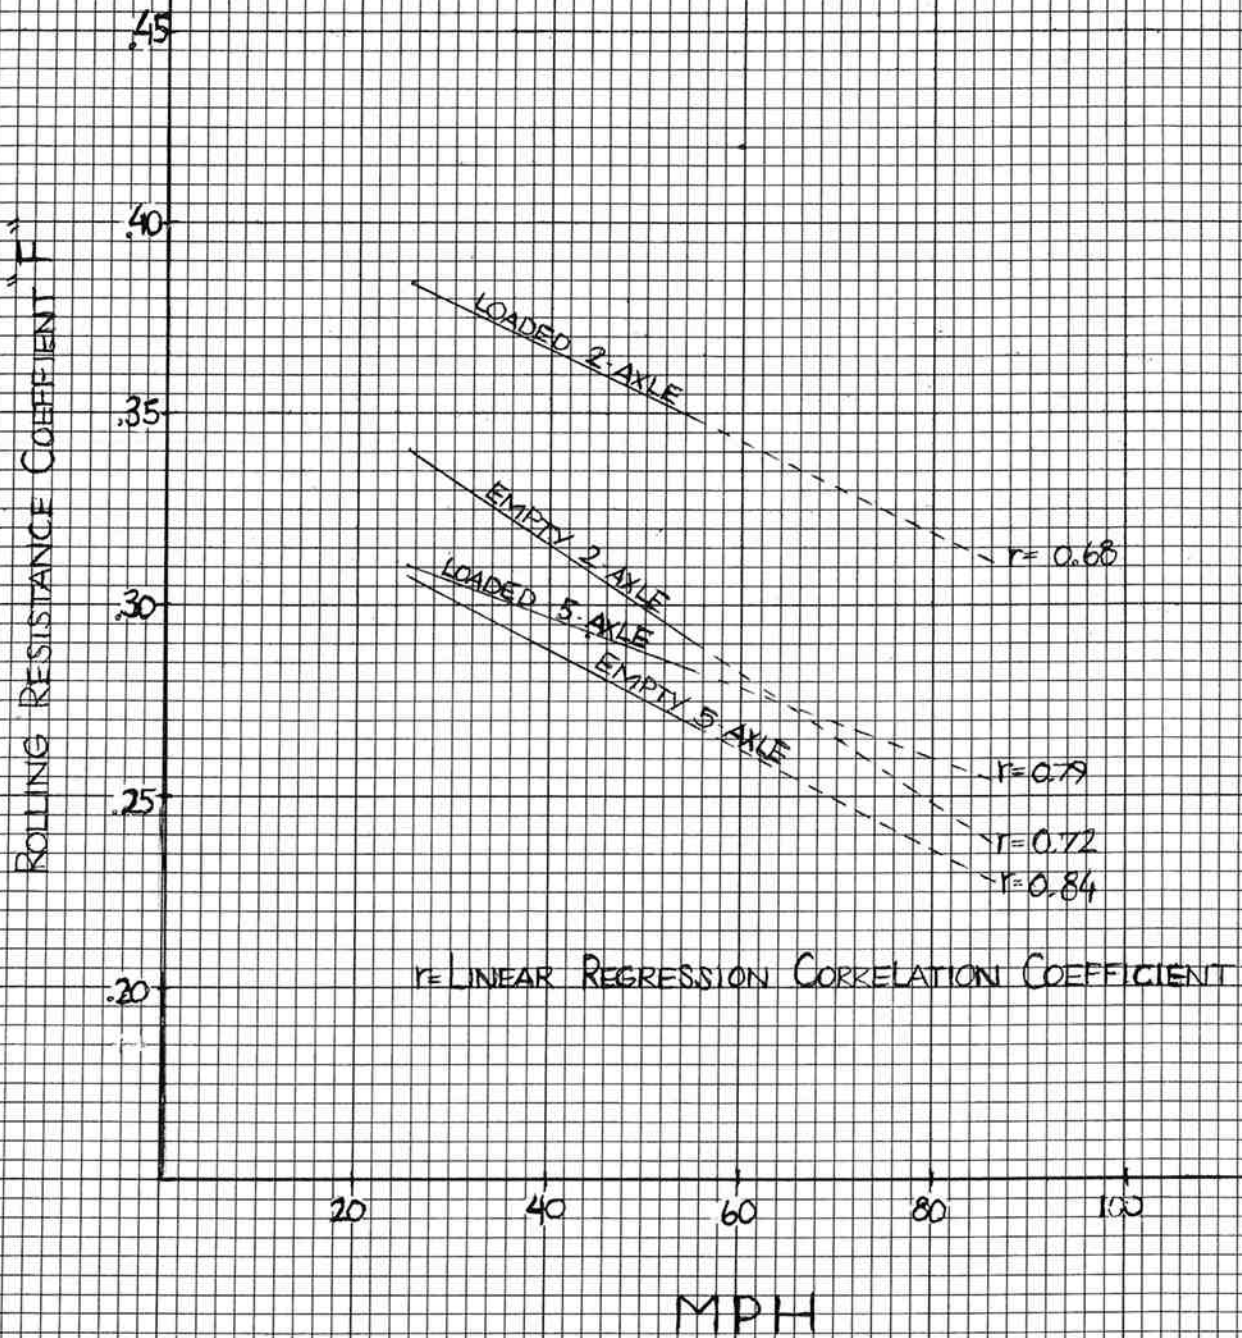
FIGURE 4

INITIAL VELOCITY
VS

RUN AVERAGED F-VALUES

The F values were then grouped into the following four categories: empty two-axle, loaded two-axle, empty five-axle and loaded five-axle. A linear regression was conducted with the data in each category (see Appendix, Figure 4). Using F-values extrapolated to 80 mph, the following stopping distances were calculated:

These calculations show that the 1200' arrester bed has adequate length to stop all of the test vehicles at an 80 mph entry velocity. Figure 4 shows that the arrester bed did not cause a constant deceleration in all trials. The run averaged F-values varied with vehicle type, axle load and initial velocity. The two-axle trucks had higher values than the five-axle trucks, the loaded trucks had higher values than the empty trucks and low initial velocities had higher values than high initial velocities.

The general trends in the relationships among velocity, axle load and F-values as shown in Figure 4 seem reasonable. Heavier axle loads and slower speeds should allow deeper penetration of the wheels into the gravel, thus causing greater resistance. However, the low correlations for the linear regression analyses emphasize the amount of scatter in the data. There were characteristics in each trial that were not easily quantifiable, such as the amount of bouncing, steering corrections, and the path traveled. These undocumented parameters make it impossible to specify the exact nature of the velocity vs. F-value and the axle load vs. F-value relationships.

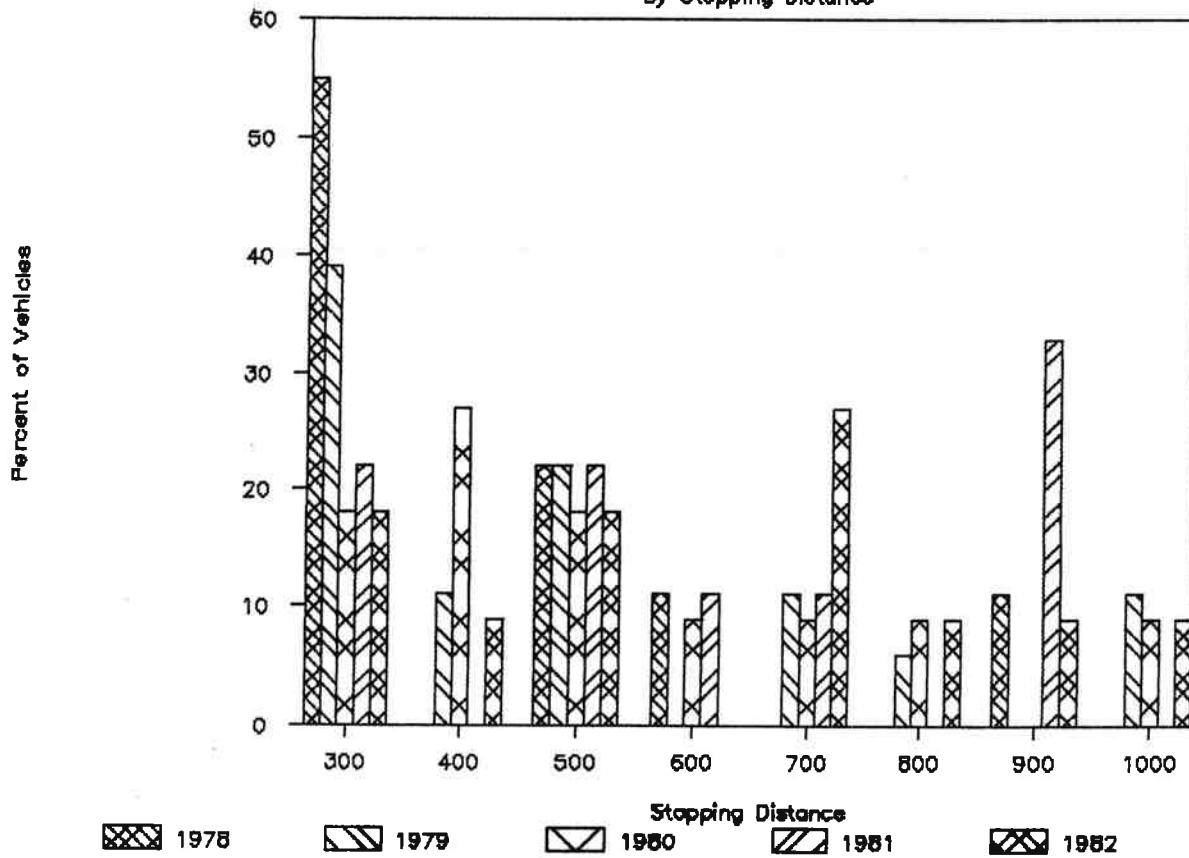
FIGURE 6

Percentage of Vehicles Using Ramp

By Stopping Distance

The Siskiyou Summit Truck Arrester Bed was completed and opened to the public in February 1978, and over four years of data are summarized in the Appendix, Figure 6. The longest stopping distance recorded was 1050 feet by a tandem trailer estimated to be traveling 85 mph. The load was lost off the second trailer, causing it to sway, but it did not overturn. There were several penetrations of more than 900 feet, one of which had an estimated 100 mph entry velocity.

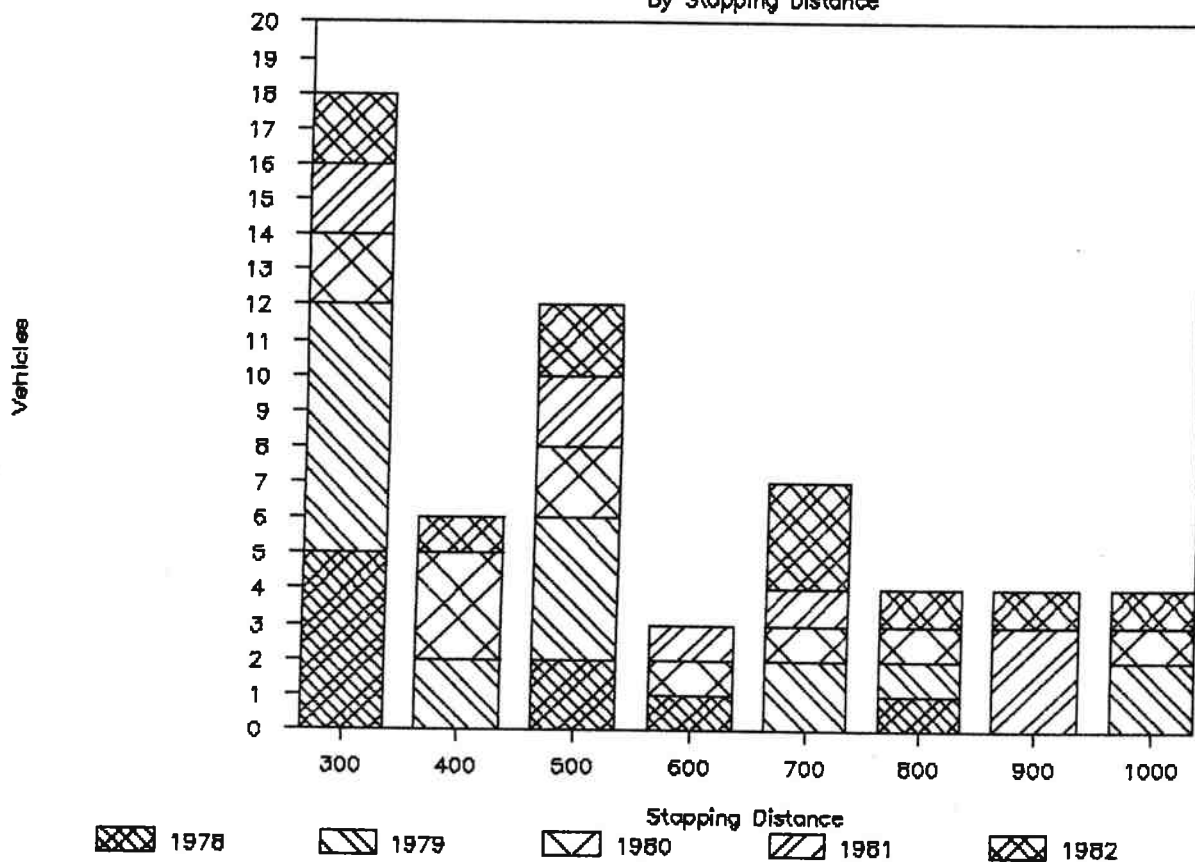
Number of Vehicles Using Ramp

By Stopping Distance
